PROPERTY INSPECTION REPORT

Inspector: L Marc Yang
Company: Elite Home Inspection Services
WA license #2337
Bothell, WA 98011
Phone: (425) 375-0891
Email: marc@eliteinsp.com
www.eliteinsp.com

Address: xx15 12th Ave S, Seattle
Client: Abc Def
Agent: Support - Home Inspector Pro

Date of Inspection: 1/15/2019
Age of House: 70 years (built in 1949)
Size: 1100 square feet
Weather: Sunny, warm

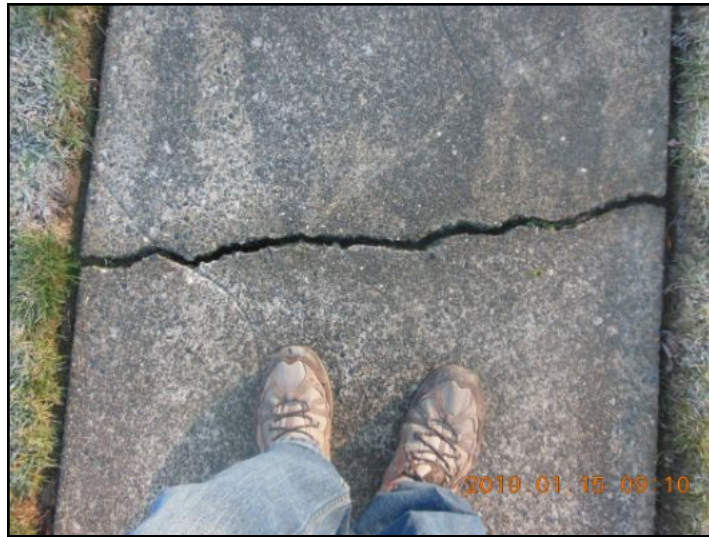
- Moderate cracks in driveway. Repair and / or monitor for expansion and development of trip hazards.

Large crack on walkway

- **IMPROVE:** Typical cracking was observed at the concrete surfaces. Further deterioration will occur as water expands and contracts from freeze and thaw cycles. Recommend sealing the cracks to prolong the life of the concrete.

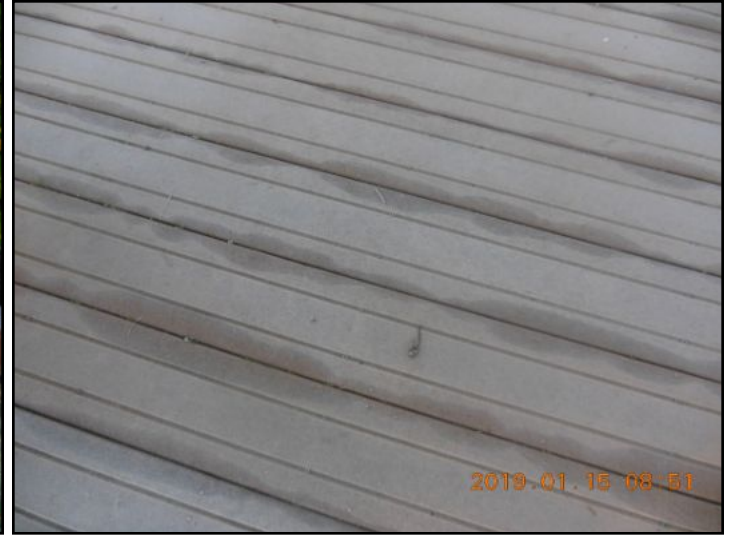
- Front deck: Composite deck boards are installed upside down.
- Front deck: Decking board spacing less than 3/8" (see photo). Recommend cleaning deck frequently to avoid accumulation of organic debris causing trapped moisture and eventual rot. Some broken boards may need repair.
- Front deck Balusters spaced to far apart > 4" and may be hazard for small child.

Composite decking boards installed upside down

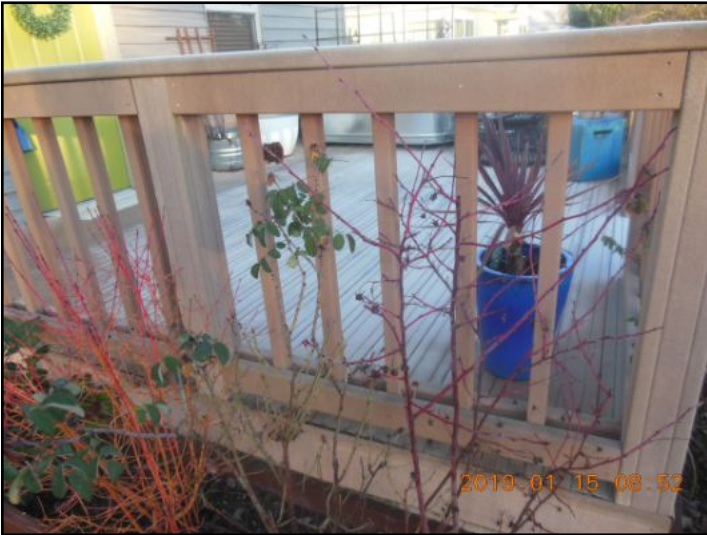
Balusters are separated >4"

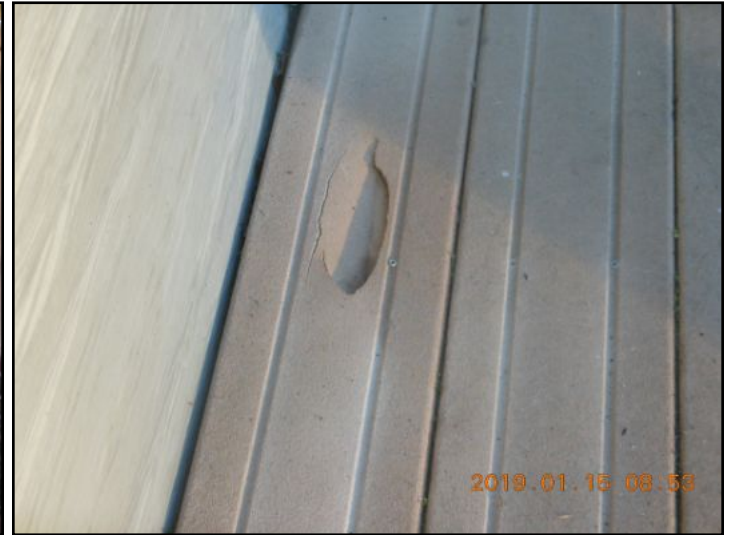
Broken deck board, front

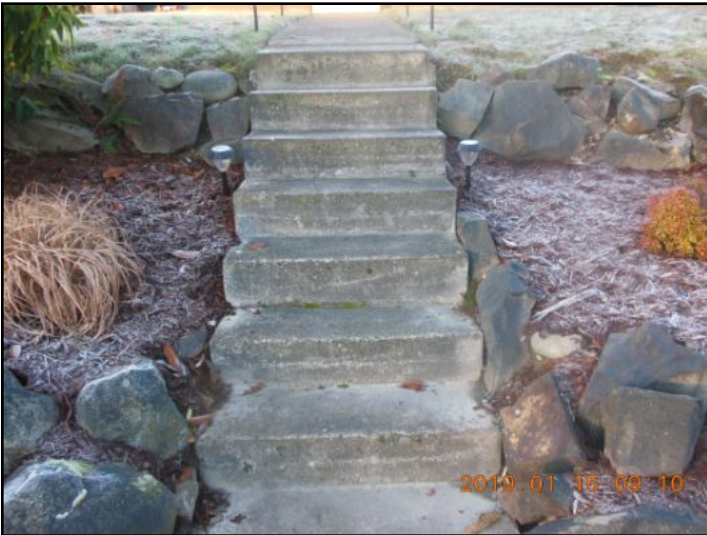
- There were no railings installed at the steps. Location: front yard. This is a potential tripping hazard. Recommend installing protective railings.
- Uneven rise of stairs could be a tripping hazard.

Front steps need handrail

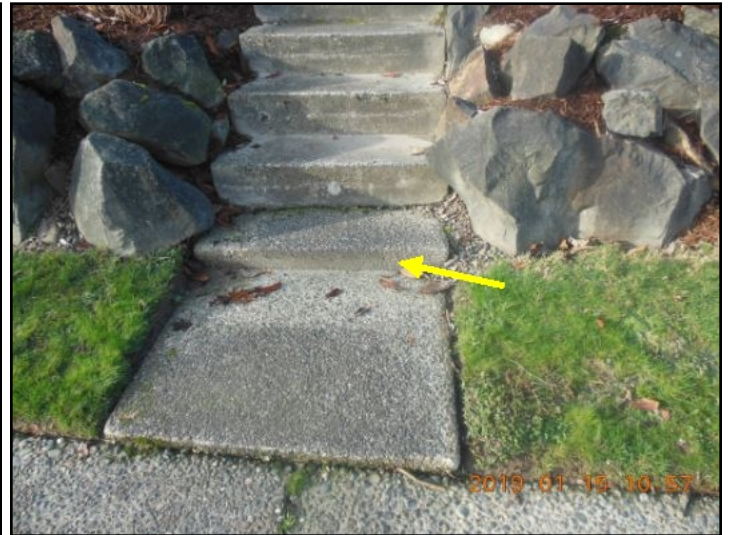
Uneven rise of step may be a tripping hazard

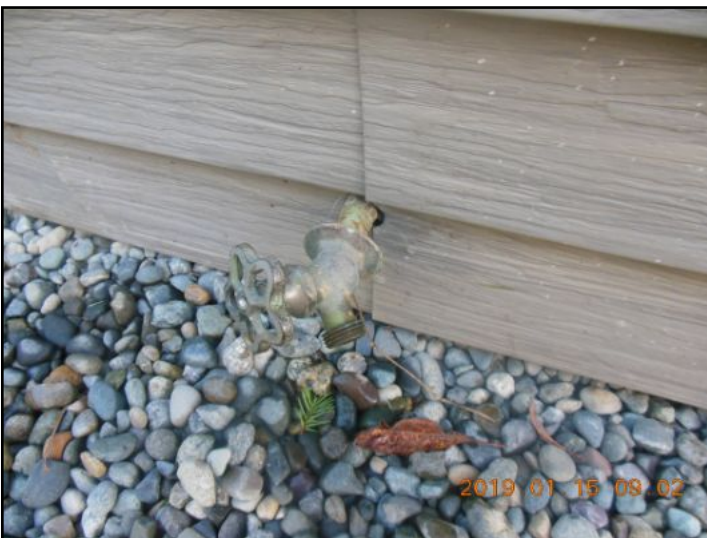
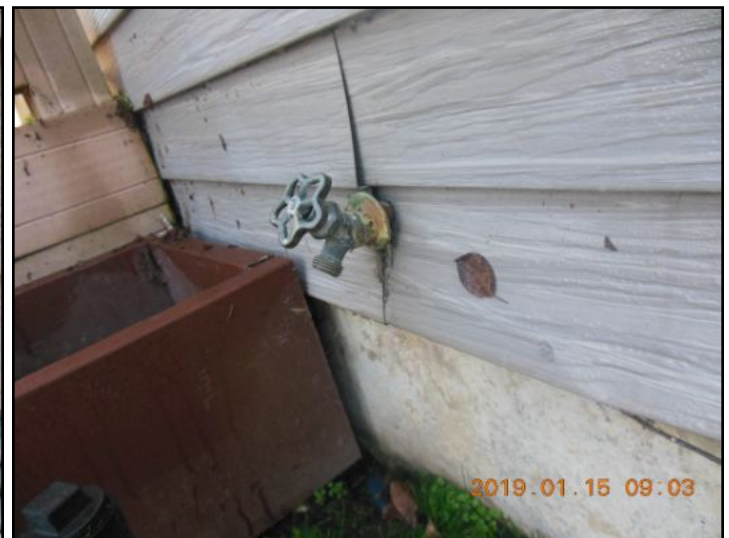
- One or more water hose bibs are not frost proof and will need to be winterized before weather turns below 32* as pipe damage can occur.
- Recommend upgrading to a frost proof type hose bibb to prevent possible damage due to cracking of water line in below freezing temperatures.

North side faucet- not frost proof

West side faucet - not frost proof

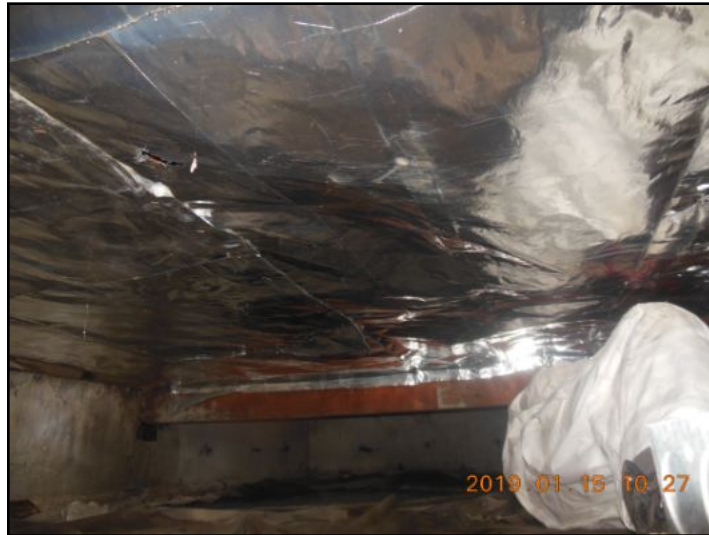
- Not visible to inspect due to complete finished ceilings. See Limitations.

Subflooring invisible due to finishing with aluminum foil covering

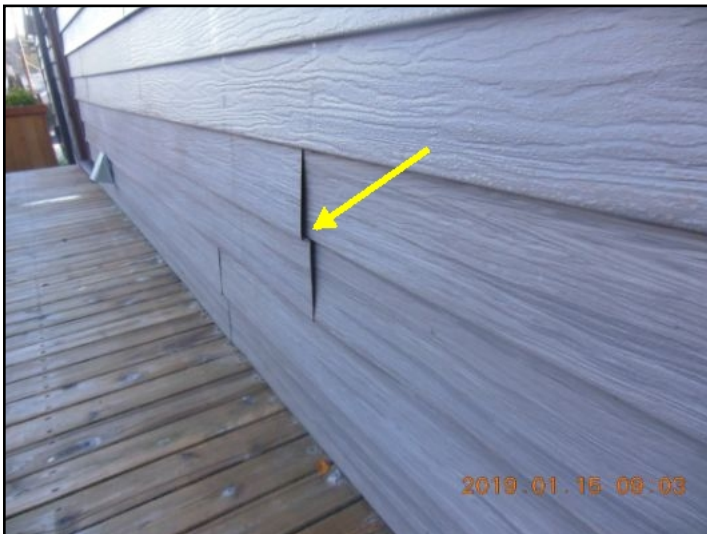
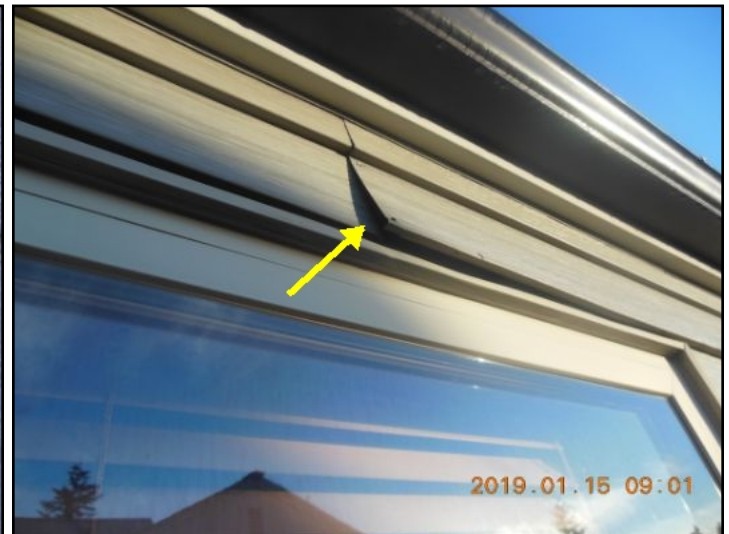
- Caulk and seal all gaps, cracks and openings (see photos).
- Siding-Soil contact or proximity. This may provide entrance of moisture or insects to siding. Recommend grading soil so there is at least 6" of space (where practical) between the siding and the soil below and checking for any damaged trim and siding materials.

Siding gaps open

Siding opening

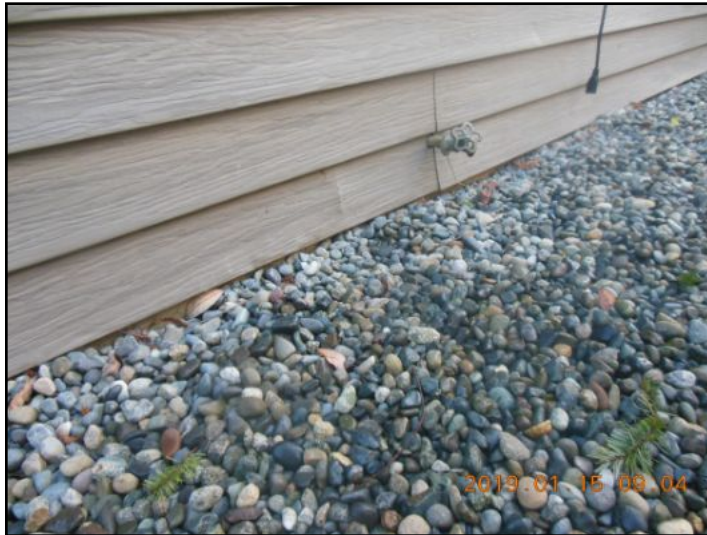
Siding contacts ground

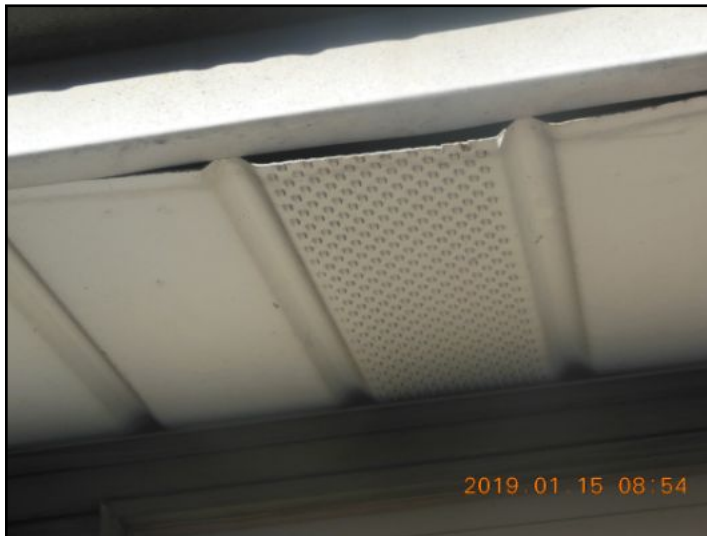
- Soffits at the home appeared to be in serviceable condition at the time of the inspection except that some metal soffit vents are loose and need minor repair.

Metal soffit vents loose, minor correction needed

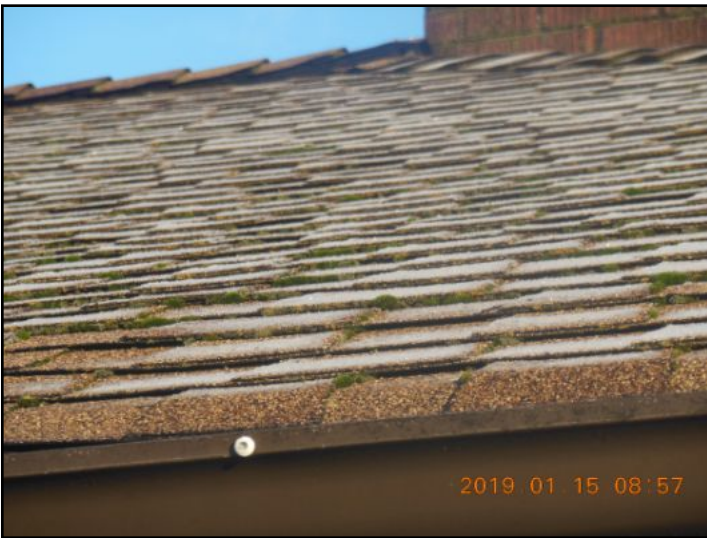
Moss on roof

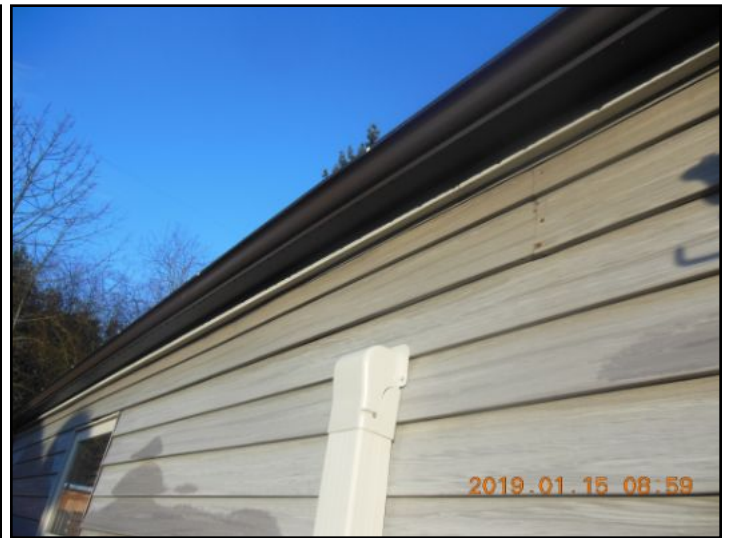
- Roof ventilation may be inadequate; this may contribute to premature roof failure, conducive conditions for mold growth in attic, and/or high heating / cooling bills. Consider further evaluation by qualified contractor.
- No major system safety or function concerns noted at time of inspection.
- Moss on roof. This can lead to the premature failure of the roof and subsequent leaks. Recommend treating moss during its growing season (wet months) with a moss killer. For information on various moss treatment products and their pros and cons, visit <http://bryophytes.science.oregonstate.edu/page24.htm>.

No roof ventilation in the back side

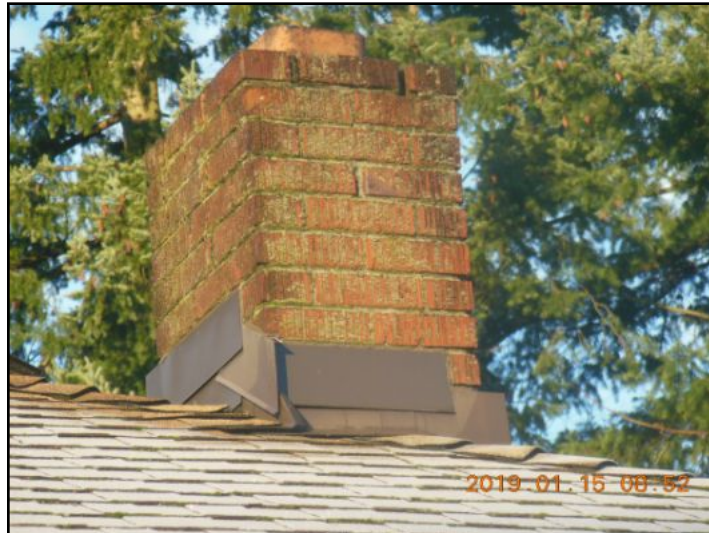
- No chimney cap visible from inspection level. Recommend installation to prevent premature weathering, water intrusion, and nesting of wildlife.
- Chimney Mortar shows sign of deterioration. Recommend having repaired as necessary.

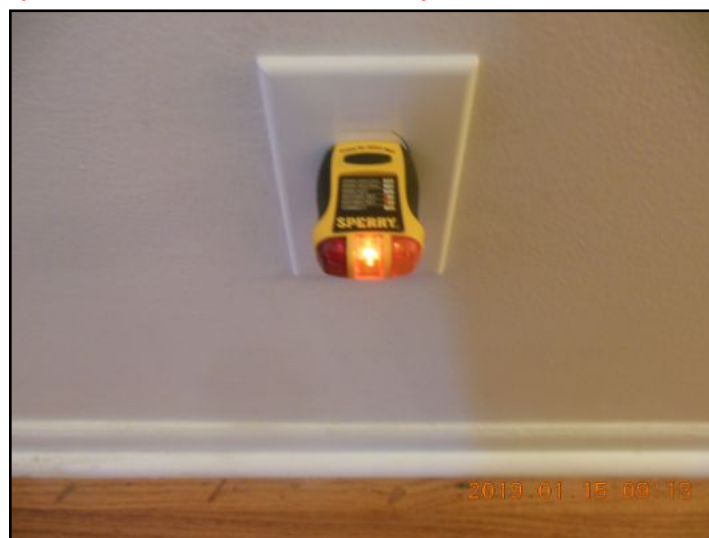
- It is **HIGHLY** recommended to (have a qualified electrician) install an Arc Fault Circuit Interrupter breaker in place of the the one currently protecting the bedroom circuits, in the near future it will be a requirement and is a very safe and sound update.
- **Open ground - receptacles in many places throughout the house.**
- **Recommend full review by qualified electrical contractor for quotes on upgrades/repair to ensure safe and adequate service.**

Outlets with open ground

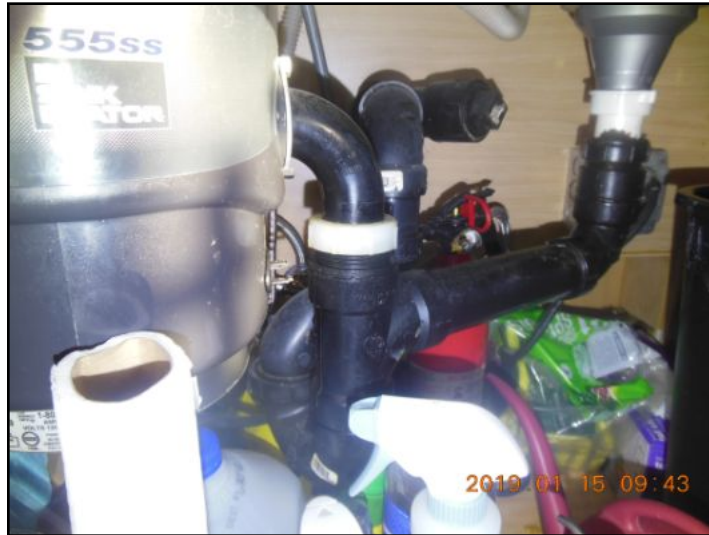
- Under sink trap is complicated and too deep (> 4"). When the trap is too deep, liquid may flow through it too fast, which can lead to siphoning of the trap seal or lead to sludge buildup.
- Recommend review by licensed plumbing contractor for repair or replacement as needed.

Drain trap too deep

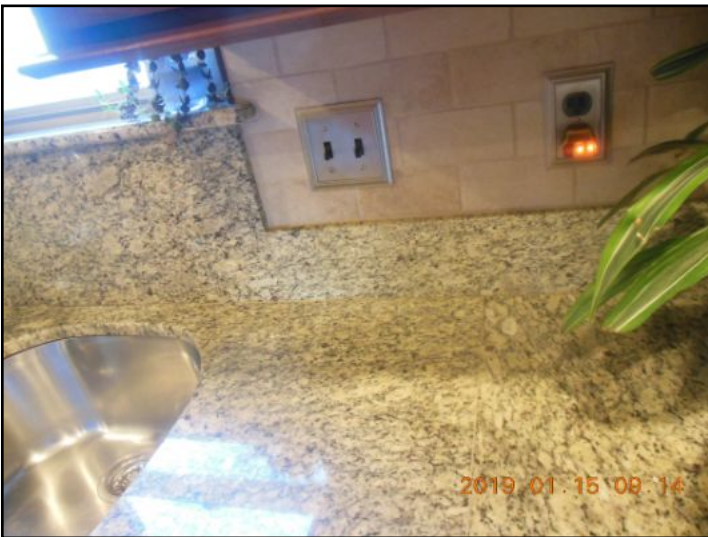
Non GFCI outlets close to sink

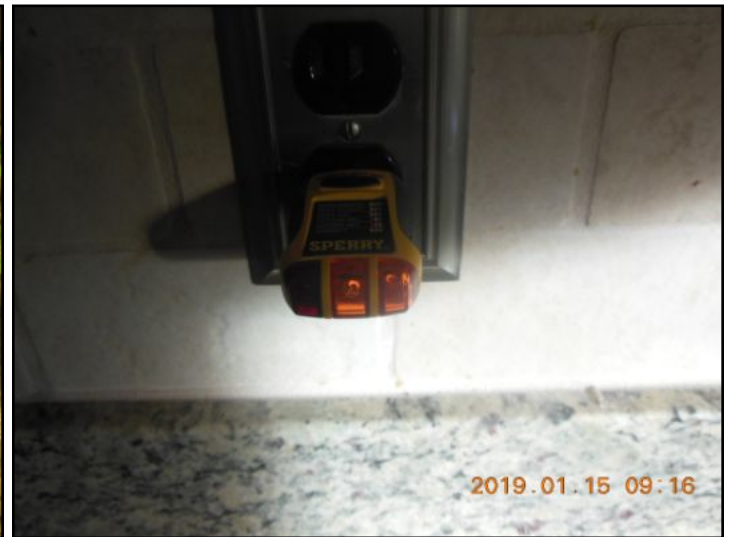
- Kitchen countertop outlet had no power.

Countertop Outlet without power

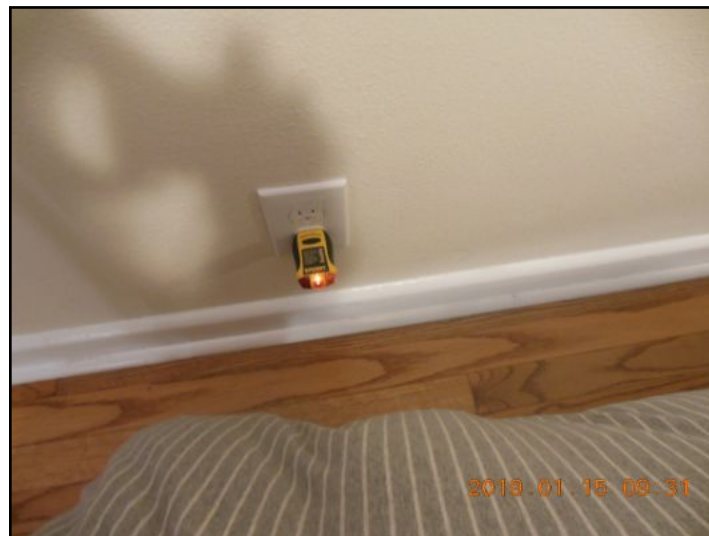
Bedrooms		
Page 26 Item: 5	Electrical	<ul style="list-style-type: none"> • Open ground - receptacle in bedrooms. This is a safety hazard and recommend correction by licensed electrician.
Bathroom

Observations:
• **Open ground - receptacle in bedrooms. This is a safety hazard and recommend correction by licensed electrician.**

Ungrounded outlets in bedrooms

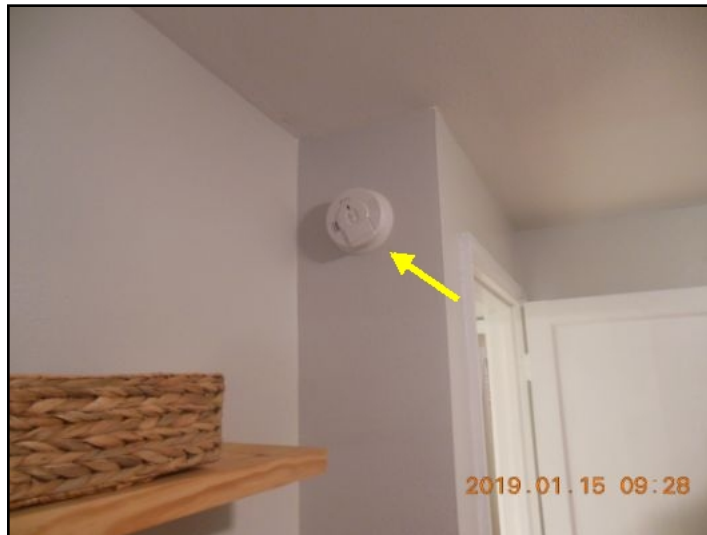
Smoke detector in north side bedroom, but absent in master bedroom

- ****Smoke Detectors****
- We recommend hard wired smoke detectors with battery backups.
- It is recommended to test CO detectors regularly.

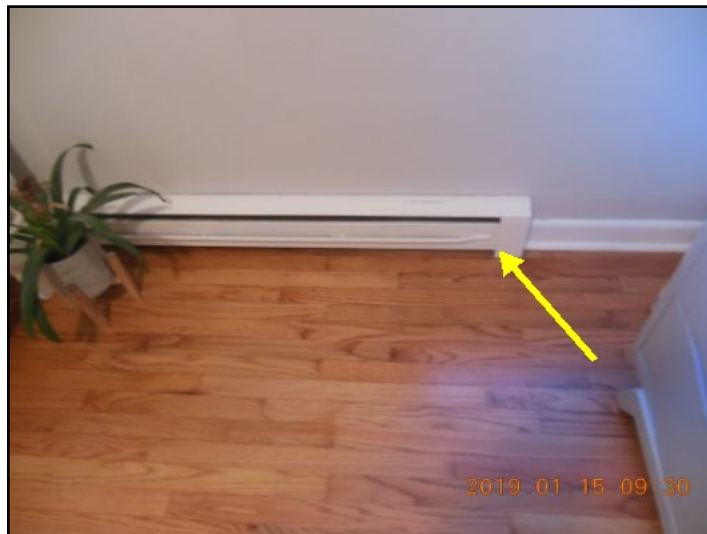
- Electric baseboard heater in master bedroom operates and functions normally, but the one in north side smaller bedroom dis not work. Professional review and repair recommended.

Electric heater did not work

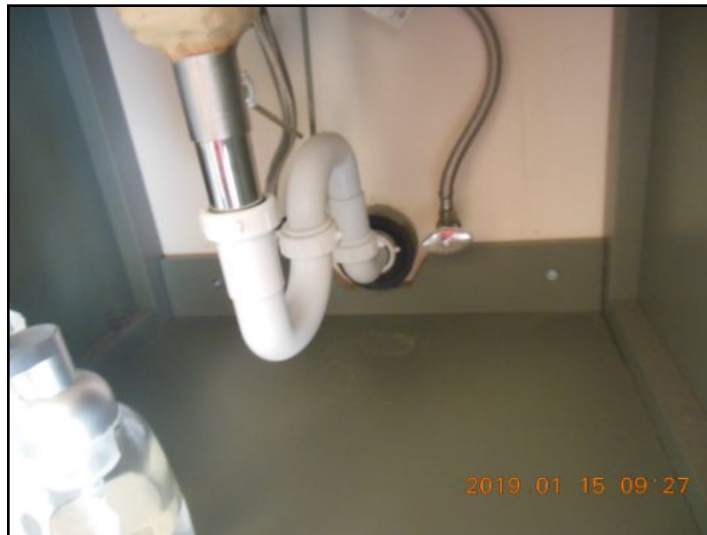
Page 31 Item: 9	Plumbing	<ul style="list-style-type: none"> • Improper "S" trap noted. This trap configuration may cause the trap to siphon dry, allowing sewer gas and odour to enter the dwelling. This situation may be rectified by the installation of an anti siphon device (cheater vent). Suggest repair by a qualified professional. In the alternative, run a little bit of water into the sink to reseal the trap if odour is detected.
Page 32 Item: 14	Toilets	<ul style="list-style-type: none"> • Toilet loose and may need re-anchoring. Recommended corrections by qualified professionals.
Laundry		
Page 33 Item: 4	GFCI	<ul style="list-style-type: none"> • No GFCI protection present, suggest installing GFCI protected receptacles for safety, by qualified electricians. • Recommend upgrading All receptacles to GFCI protection within 6 feet of all potential wet locations in the house, by a qualified electrician.

• Improper "S" trap noted. This trap configuration may cause the trap to siphon dry, allowing sewer gas and odour to enter the dwelling. This situation may be rectified by the installation of an anti siphon device (cheater vent). Suggest repair by a qualified professional. In the alternative, run a little bit of water into the sink to reseal the trap if odour is detected.

Improper S trap plumbing under bathroom sink

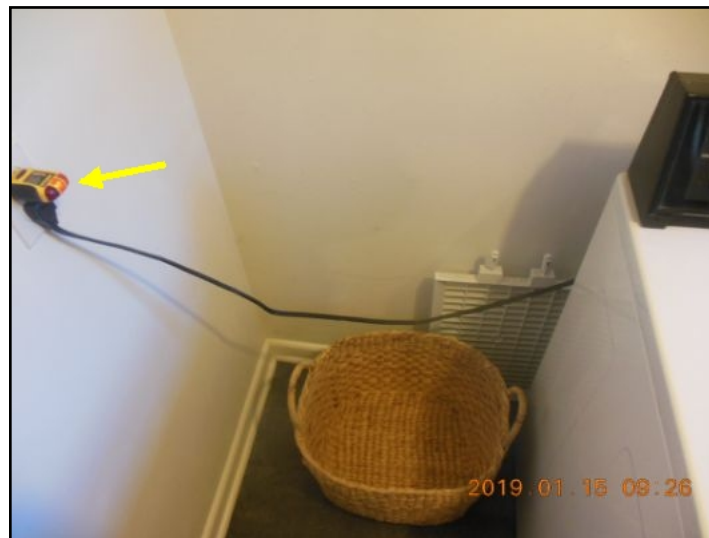
- Open ground - receptacle for washer.

Outlet for washer has open ground

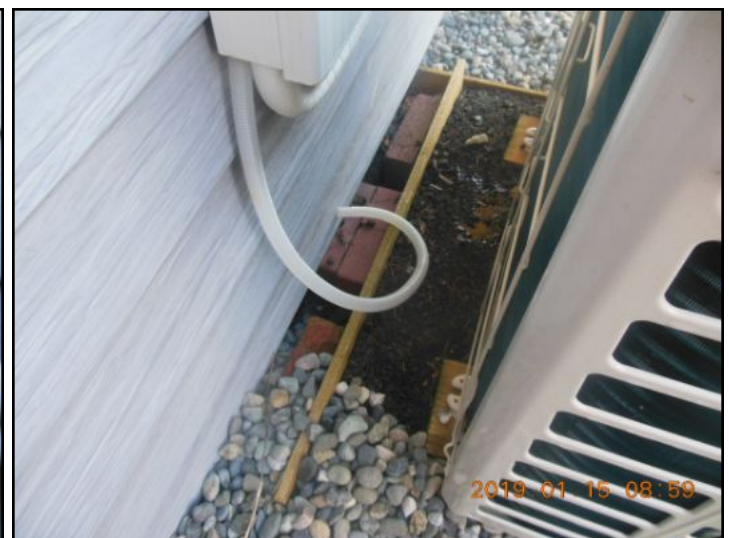
- The condensation drain line of the heat pump discharge close to the foundation and may cause water penetration to the crawl space. The condensation should be discharged to approved plumbing fixture or disposal area sloped away from the foundation.

Condensation line discharges closely to foundation

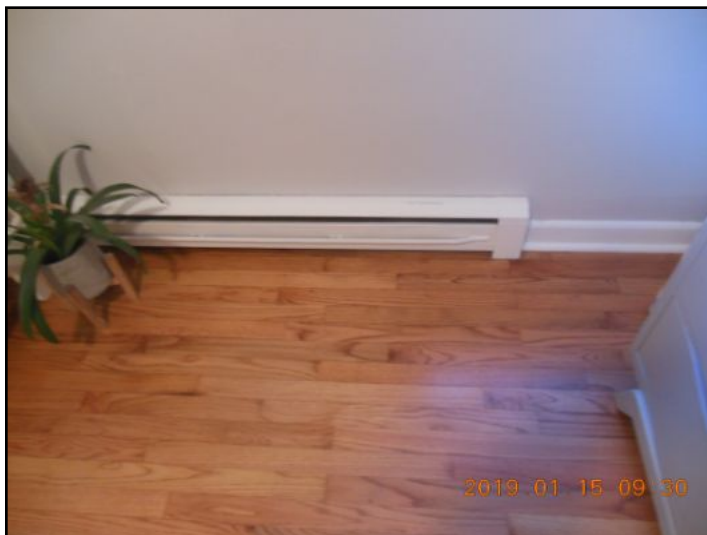
Heat/AC		
Page 35 Item: 1	Heater Condition	<ul style="list-style-type: none"> • Electric baseboard heater in north side bedroom does not respond to thermostat and repair or replacement by professionals recommended.
Water Heater		
Page 38 Item: 6	Strapping	<ul style="list-style-type: none"> • The water heater is not secured by strapping. Two straps were recommended to be installed by qualified professionals. For proper strapping of water heater please see: https://www.doh.wa.gov/Emergencies/BePreparedBeSafe/GetReady/WaterHeatersHowtosecurethem
Electrical		
Page 40 Item: 4	Cable Feeds	<ul style="list-style-type: none"> • There is an overhead service drop noted. • Masthead is loose or improperly secured, recommend review by a licensed electrician for repair or replacement as necessary. • Normal acceptable clearance of the power line to the roof is >3' at the closest point. The power line is too close to the roof/gutter and is a serious safety issue.

- **Electric baseboard heater in north side bedroom does not respond to thermostat and repair or replacement by professionals recommended.**

Electric heater in the small bedroom does not respond to thermostat control

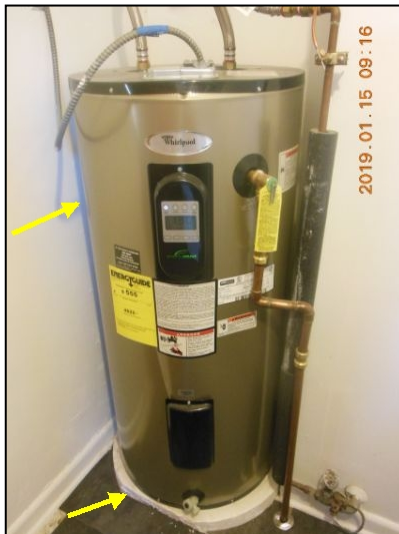
- Water Source: Public
- Tank appears to be in satisfactory condition and manufactured in 2013.
- A Temperature Pressure Relief (TPR) valve present. This safety valve releases water (and thus relieves pressure) if either the temp or pressure in the tank gets too high. The **TPR valve** discharge tube must be made of copper, iron, or CPVC (NOT regular **PVC**). It must terminate within 6" above the floor--the end cannot be threaded or have a fitting.

No earthquake straps and no drain pan

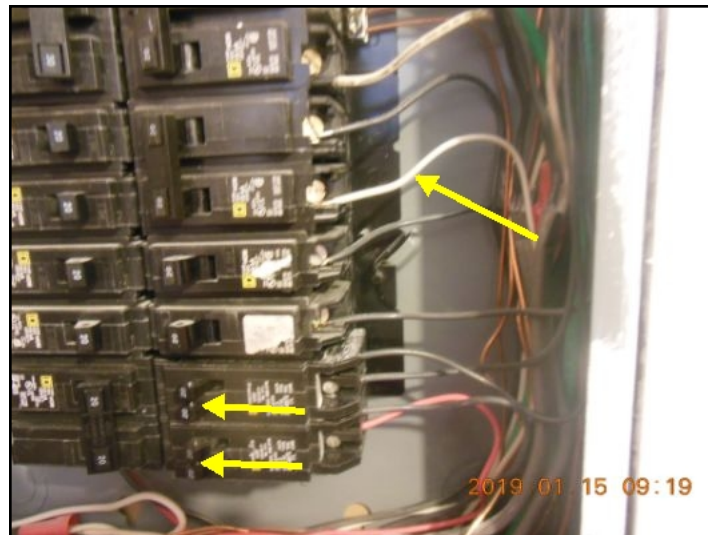
- Exposed wire ends in panel box. Have evaluated by a licensed electrician.
- White live wire should be labeled black.
- Breaker handle ties are missing for multi-wire circuit breakers.
- Recommend having breakers evaluated by a licensed electrician.

white live wires should be labeled black and handle ties are needed for some breakers

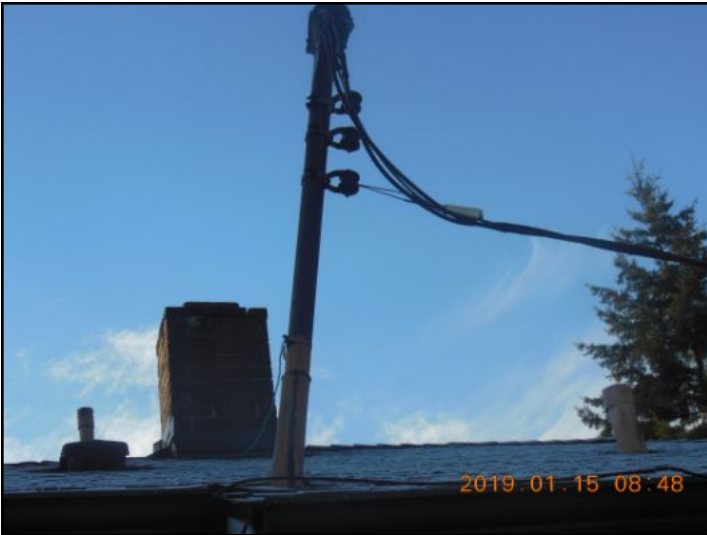
- There is an overhead service drop noted.
- Masthead is loose or improperly secured, recommend review by a licensed electrician for repair or replacement as necessary.
- Normal acceptable clearance of the power line to the roof is >3' at the closest point. The power line is too close to the roof/gutter and is a serious safety issue.

Service mast is not secured

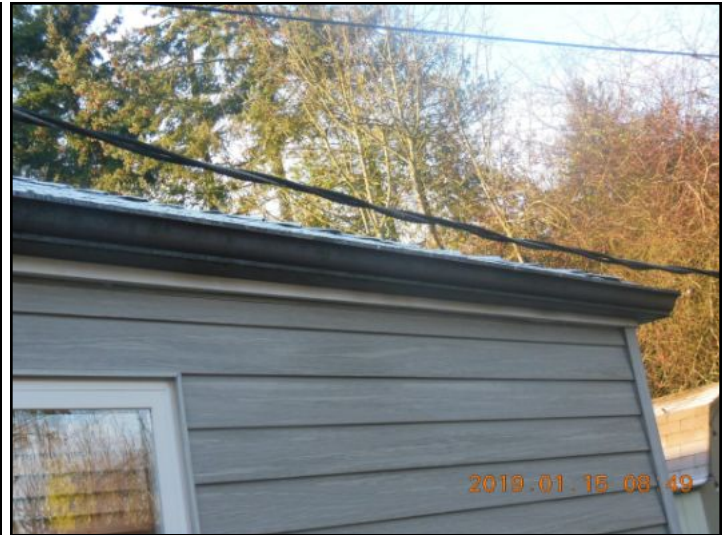
Service drop too close to roof

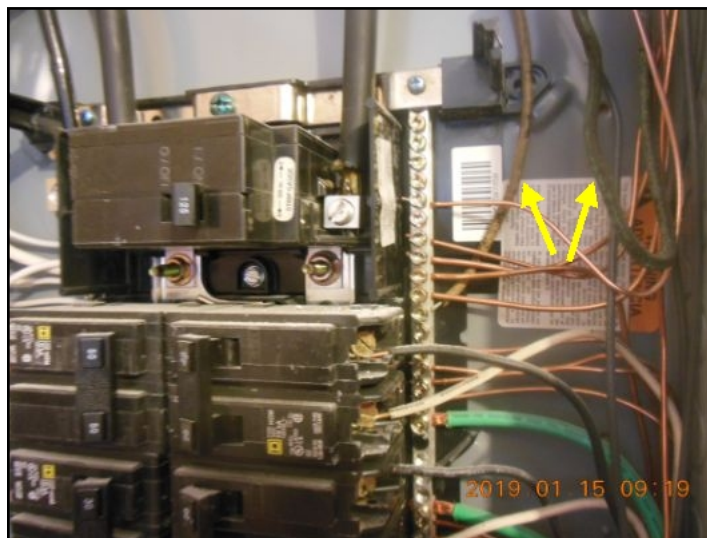
- Although the circuit breakers appeared serviceable, old wires with cloth sheathing were observed and may indicate live knob and tube wiring.
- We recommend contacting a licensed electrician to evaluate the knob and tube wiring system and correct as necessary for safety concerns.

old wires

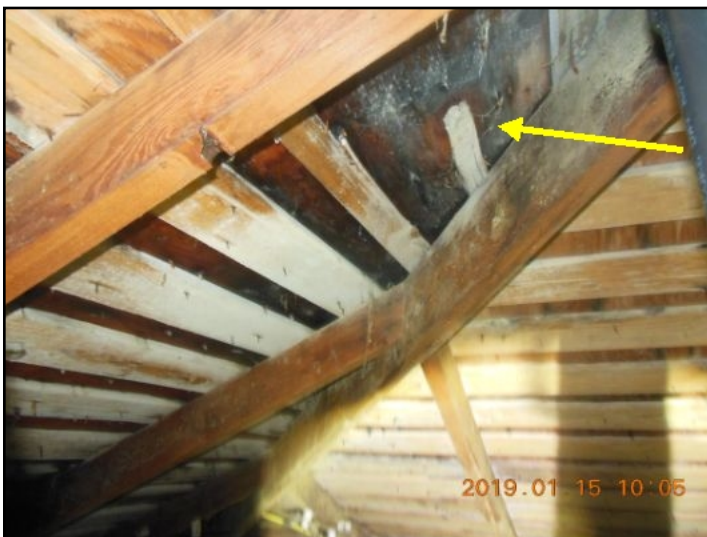
Attic		
Page 41 Item: 2	Structure	<ul style="list-style-type: none"> • Evidence of past or present leaks, dry at time of the inspection. Monitor for leaks &/or have roofing contractor evaluate. • Possible organic growth noted. The United States Environmental Protection Association (EPA) states, "If you believe that you may have a hidden mold problem, consider hiring a professional." (Brief Guide to Mold, p.14, EPA). Recommend evaluation by professional mold inspector/contractor. • Inspected from access hole only, limited space in attic prevented entry.
Page 42 Item: 6	Electrical	<ul style="list-style-type: none"> • Knob and tube wiring present, cannot be sure if it has been disconnected. • Open junction boxes were observed, which is a safety concern. Recommend installing proper covers, as needed, for safety. • Recommend electrician to evaluate.
Basement/Crawlspace

- **Evidence of past or present leaks, dry at time of the inspection. Monitor for leaks &/or have roofing contractor evaluate.**
- **Possible organic growth noted. The United States Environmental Protection Association (EPA) states, "If you believe that you may have a hidden mold problem, consider hiring a professional." (Brief Guide to Mold, p.14, EPA). Recommend evaluation by professional mold inspector/contractor.**
- **Inspected from access hole only, limited space in attic prevented entry.**

Broken sheathing board and past leaks

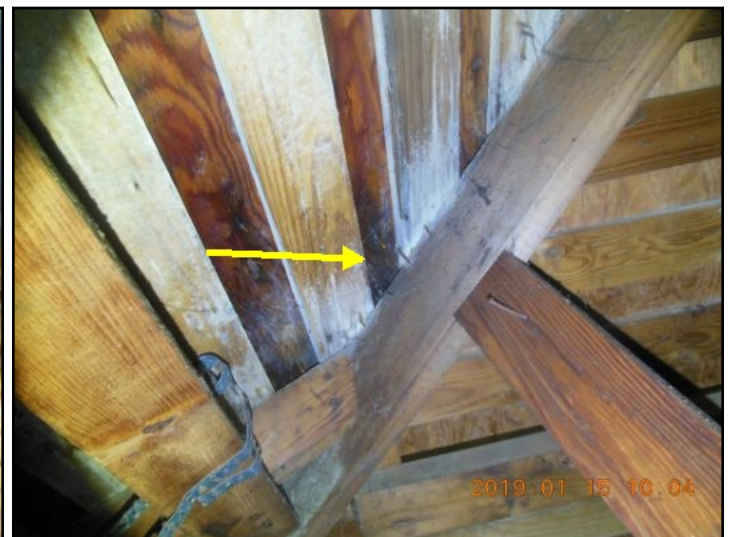
Potential biogrowth/mold

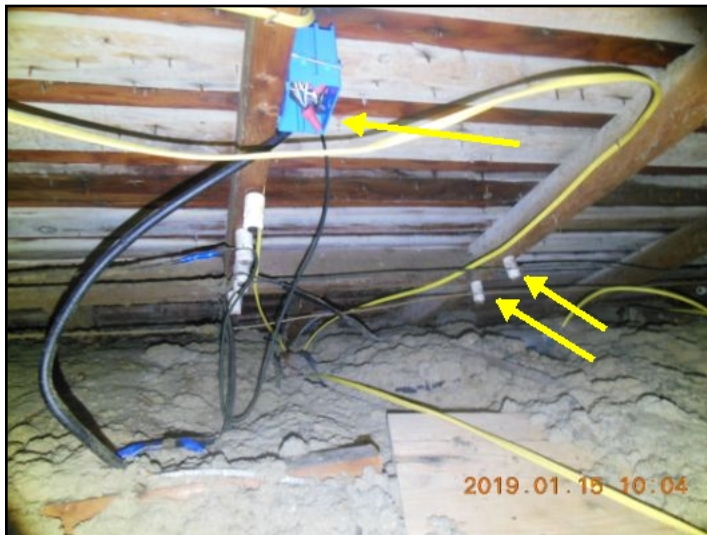
- Knob and tube wiring present, cannot be sure if it has been disconnected.
- Open junction boxes were observed, which is a safety concern. Recommend installing proper covers, as needed, for safety.
- Recommend electrician to evaluate.

Knob and tube wiring and missed junction box cover

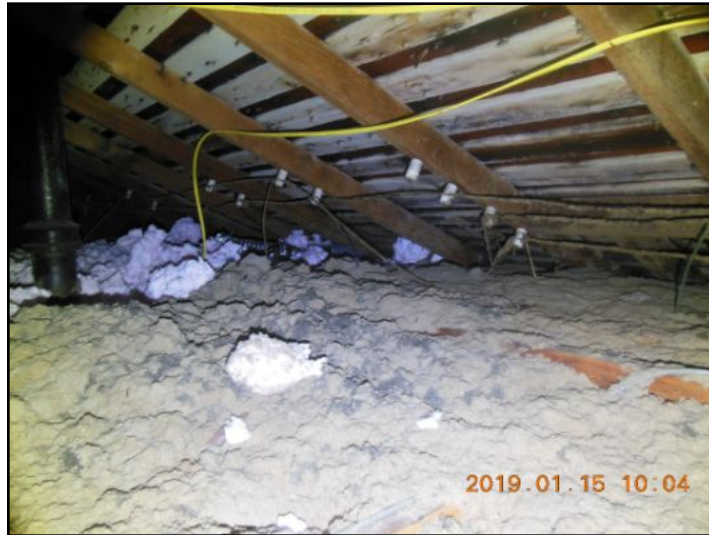
- No insulation over attic hatch; recommend installation, then sealing hatch with caulk to minimize heat loss.
- Insulation is sparse in some areas.
- Insulation is covering knob and tube wiring.
- Recommend upgrade the insulation by a professional contractor.

Uneven insulation

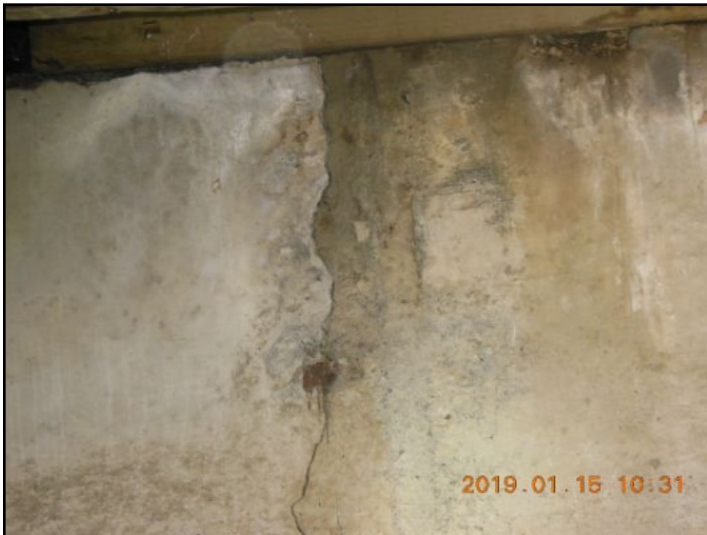
Page 44 Item: 1	Walls	<ul style="list-style-type: none">• Large cracks were observed at the visible foundation walls. Repairs can be expensive and further settling or damage could occur. Recommend a Structural Engineer to provide a detailed analysis.• Moisture intrusion was observed in numerous areas of the foundation. Moisture can create high humidity, mold & can damage stored items & finishing materials. Recommend a wet basement specialist review the foundation for correcting the water intrusion and advise as needed.• Large hole was observed under foundation footing probably from previous water supply installation. Recommend professional review and repair as necessary, by qualified contractors.
Page 45 Item: 5	Drainage	<ul style="list-style-type: none">• Water puddles in multiple sites of crawl space.• Recommend further review of current perimeter foundation drainage system by a Qualified Foundation Drainage Contractor. Drain pit appears to be insufficient and may allow water to enter structure in the event of a heavy rainfall.• Wrong type of vapor barrier was installed. Black 6 mil plastic barrier is recommended.

- Large cracks were observed at the visible foundation walls. Repairs can be expensive and further settling or damage could occur. Recommend a Structural Engineer to provide a detailed analysis.
- Moisture intrusion was observed in numerous areas of the foundation. Moisture can create high humidity, mold & can damage stored items & finishing materials. Recommend a wet basement specialist review the foundation for correcting the water intrusion and advise as needed.
- Large hole was observed under foundation footing probably from previous water supply installation. Recommend professional review and repair as necessary, by qualified contractors.

Large crack on foundation wall

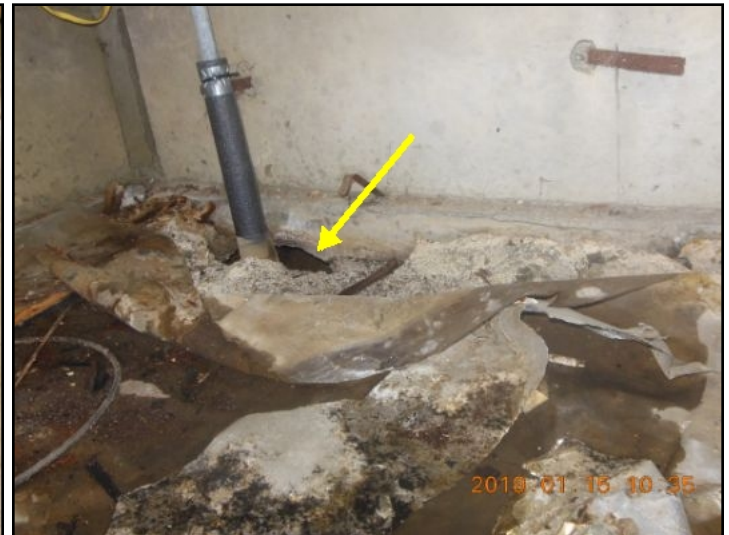
Water puddles and large hole under foundation footing

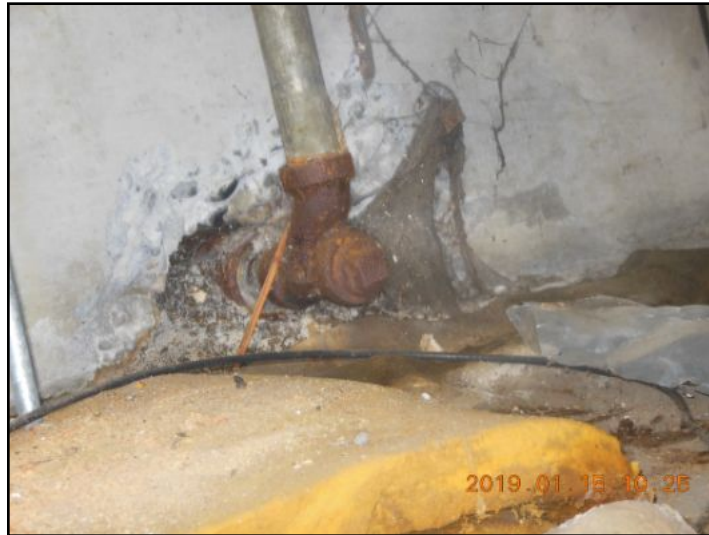
- Corrosion/cysts were noted as one or more locations of the metal drain lines. Repairs recommended to be performed by a Qualified Plumber.

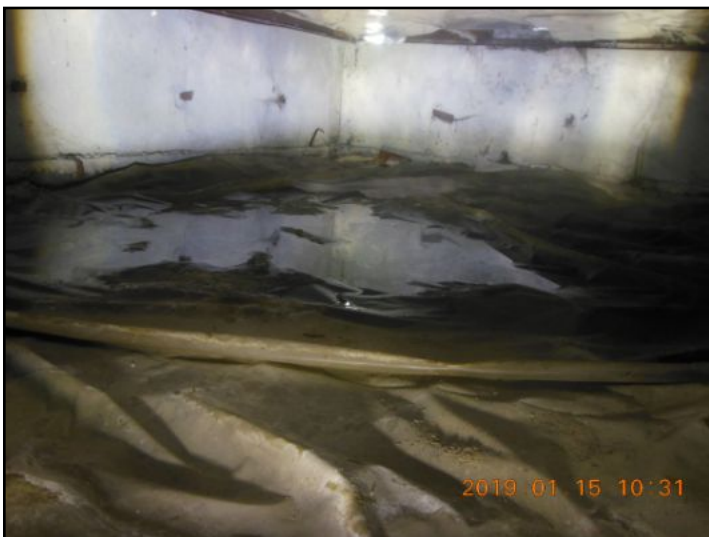
- Water puddles in multiple sites of crawl space.
- Recommend further review of current perimeter foundation drainage system by a Qualified Foundation Drainage Contractor. Drain pit appears to be insufficient and may allow water to enter structure in the event of a heavy rainfall.
- Wrong type of vapor barrier was installed. Black 6 mil plastic barrier is recommended.

Water puddle in crawl space

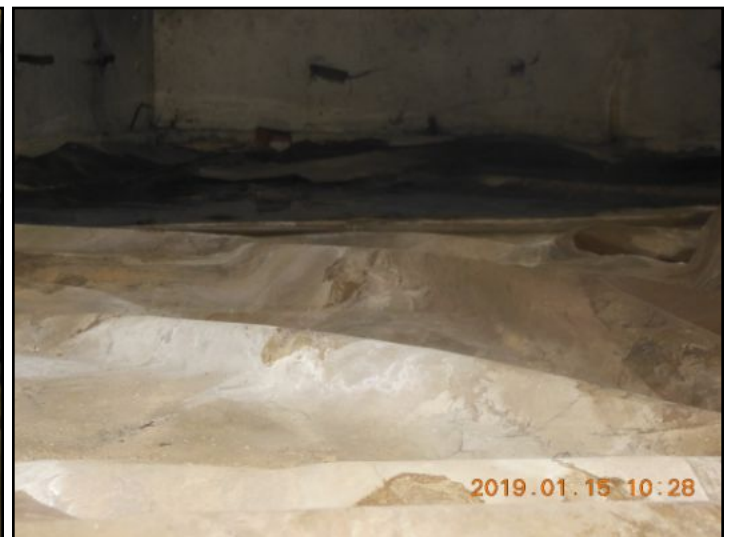
Wrong type of vapor barrier

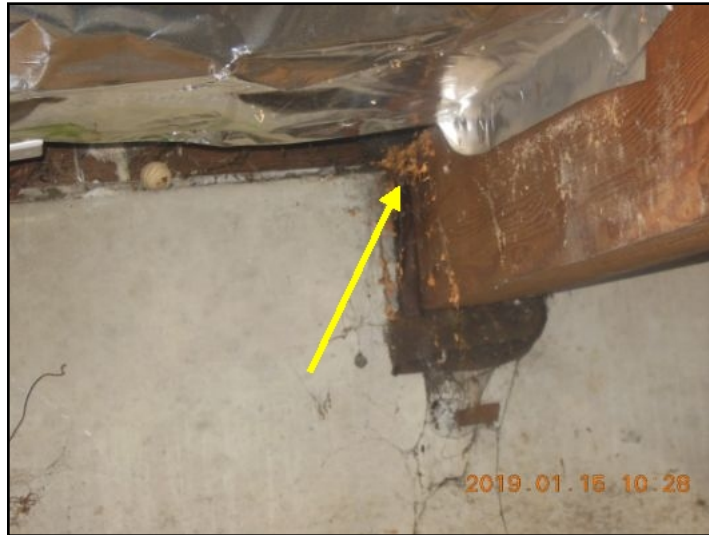
Page 46 Item: 6	Framing	<ul style="list-style-type: none">• Wood beam showed signs of insect damage. A licensed Structural Pest inspector was recommended for further evaluation and treated as needed.

- ****BEAMS****
- Wood beam and posts- as with any wood, monitor for any changes and maintain well for longevity.
- Wood beam showed signs of insect damage. A licensed Structural Pest inspector was recommended for further evaluation and treated as needed.

Frass present
